**Table 3-13**  
**Summary of SWMUs/AOCs**  
**(Sheet 5 of 18)**

Source: Jacobs, 1993. MCAS El Toro Final RCRA Facility Assessment Report.  
Bechtel National, Inc., 1995. MCAS El Toro Draft Final Addendum to the RCRA Facility Assessment (Volume 6 of the Final RFA Report).  
SAIC 1994. Draft Oil and Hazardous Substances Spill Prevention and Countermeasure Plan and Contingency Plan (SPCC)

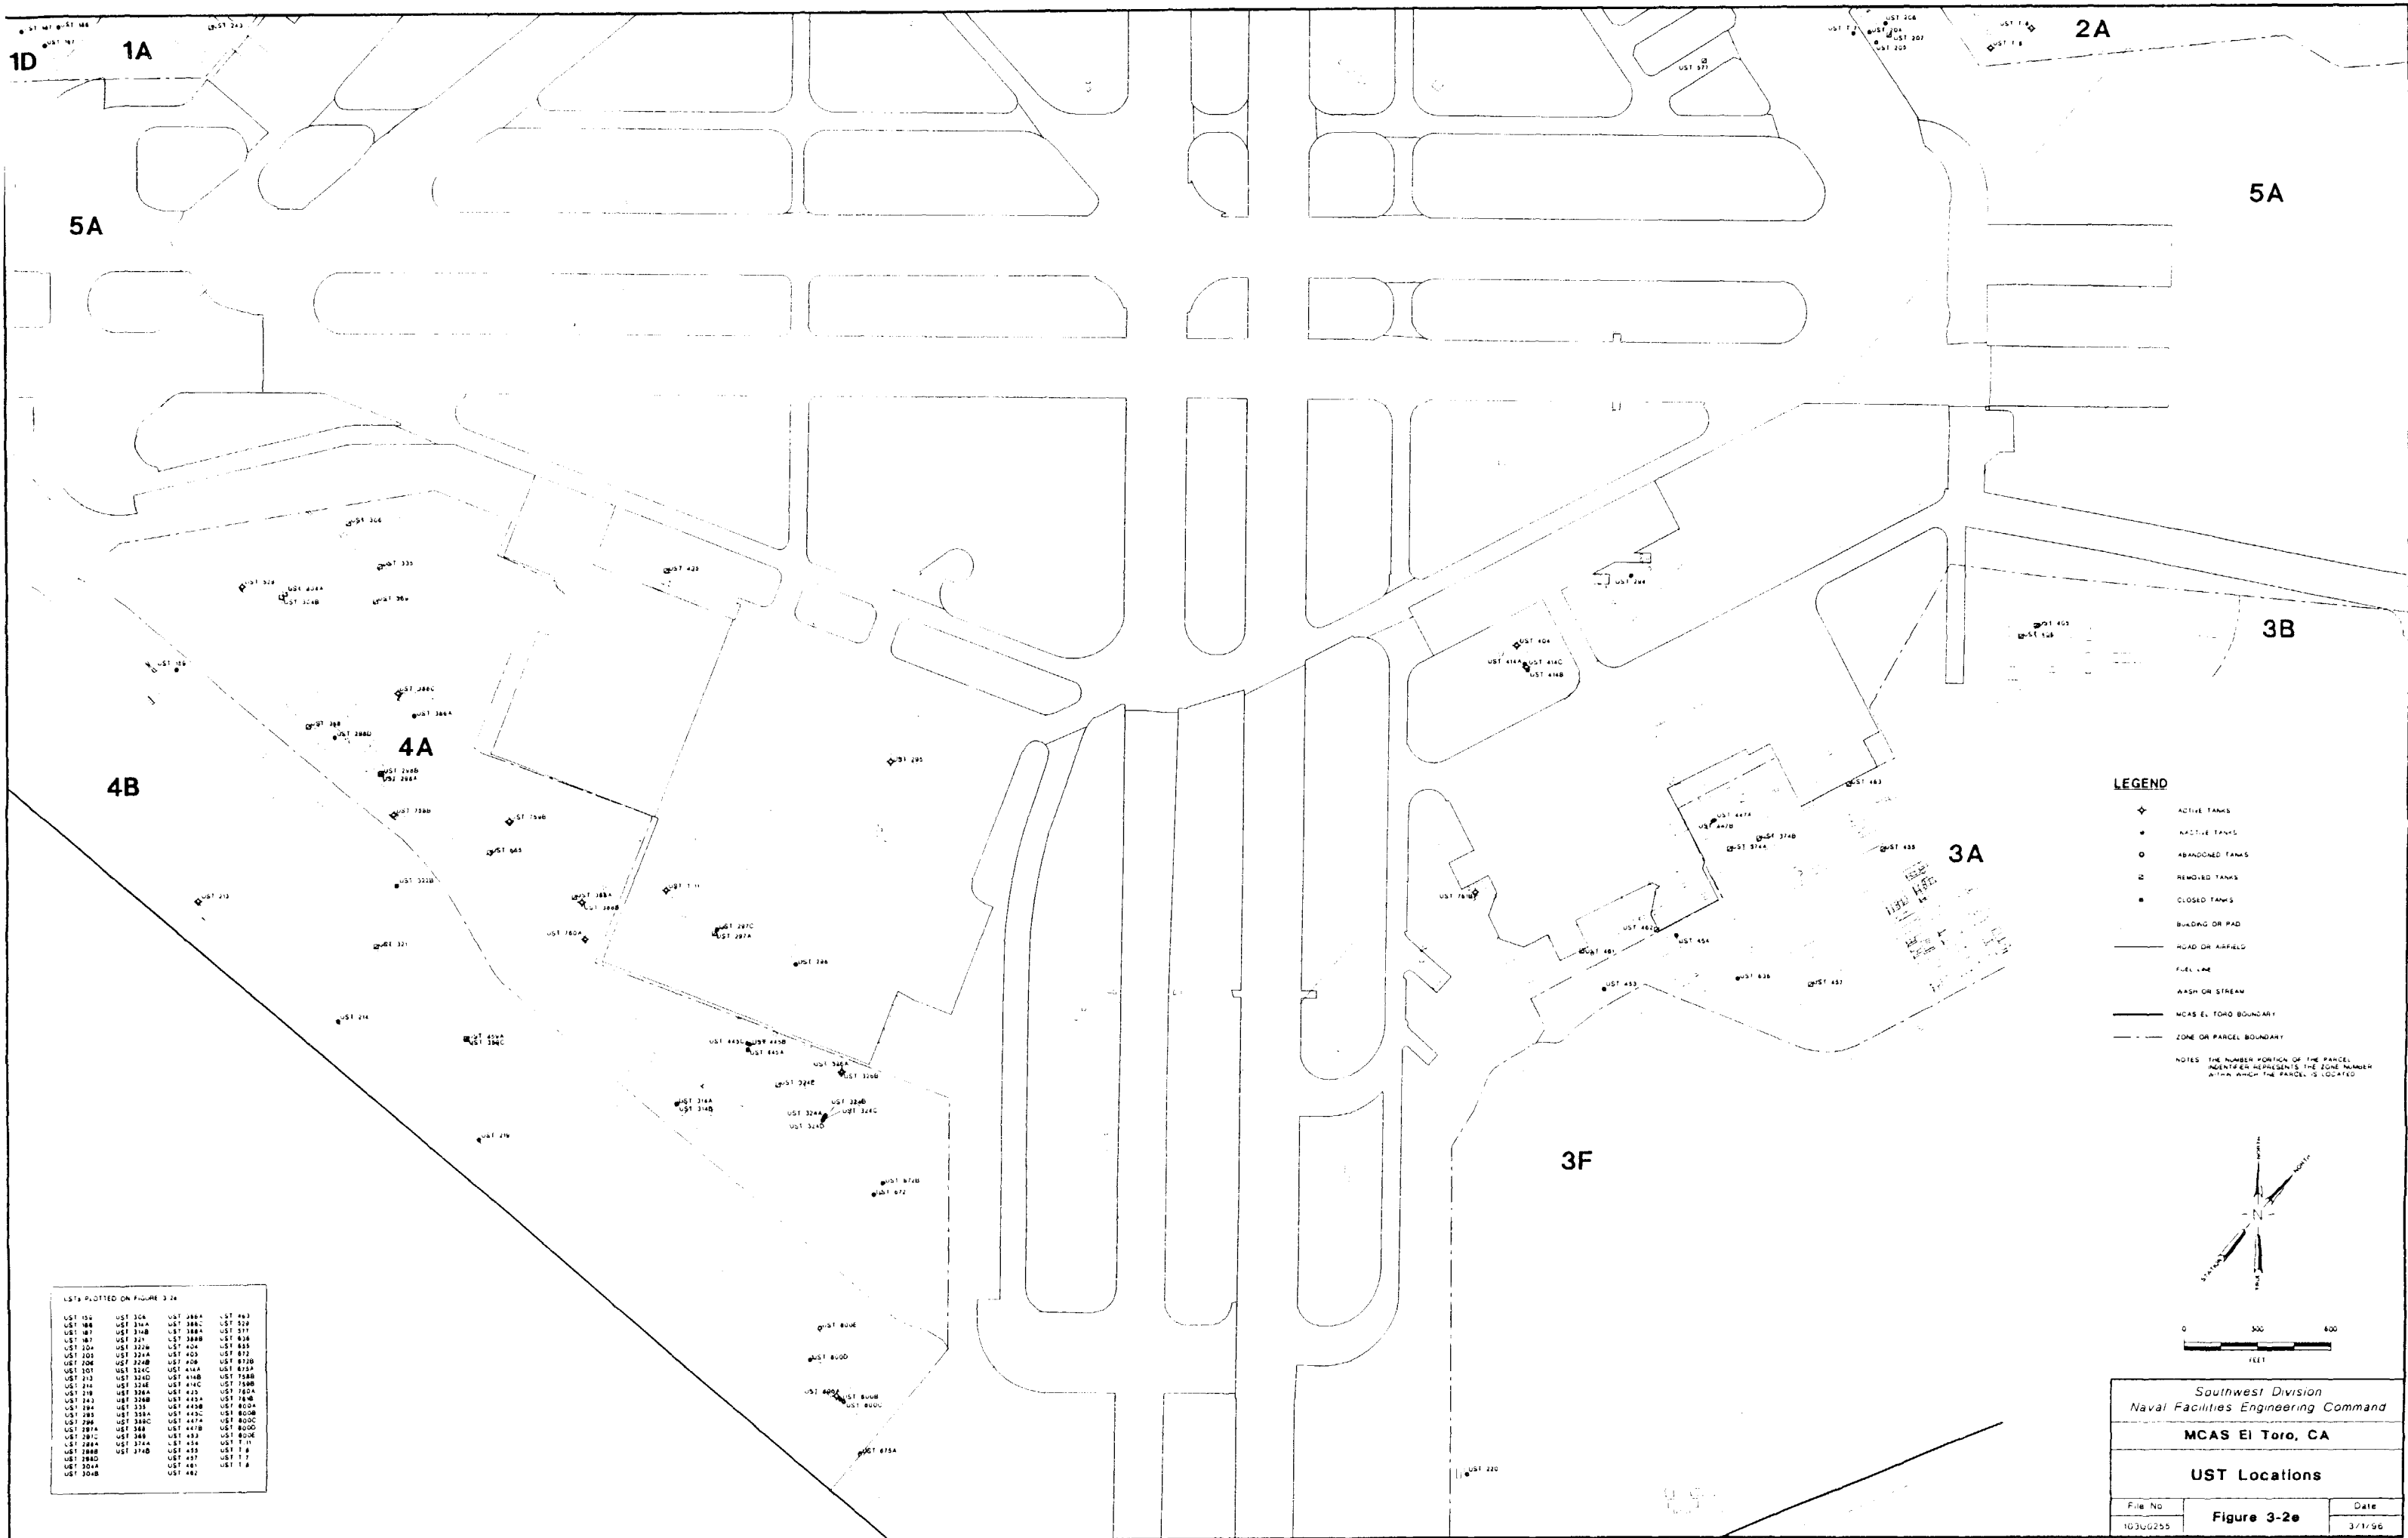
USTs PLOTTED ON FIGURE 3-26

UST 100	UST 300	UST 300A	UST 400
UST 101	UST 301	UST 301A	UST 401
UST 102	UST 302	UST 302A	UST 402
UST 103	UST 303	UST 303A	UST 403
UST 104	UST 304	UST 304A	UST 404
UST 105	UST 305	UST 305A	UST 405
UST 106	UST 306	UST 306A	UST 406
UST 107	UST 307	UST 307A	UST 407
UST 108	UST 308	UST 308A	UST 408
UST 109	UST 309	UST 309A	UST 409
UST 110	UST 310	UST 310A	UST 410
UST 111	UST 311	UST 311A	UST 411
UST 112	UST 312	UST 312A	UST 412
UST 113	UST 313	UST 313A	UST 413
UST 114	UST 314	UST 314A	UST 414
UST 115	UST 315	UST 315A	UST 415
UST 116	UST 316	UST 316A	UST 416
UST 117	UST 317	UST 317A	UST 417
UST 118	UST 318	UST 318A	UST 418
UST 119	UST 319	UST 319A	UST 419
UST 120	UST 320	UST 320A	UST 420
UST 121	UST 321	UST 321A	UST 421
UST 122	UST 322	UST 322A	UST 422
UST 123	UST 323	UST 323A	UST 423
UST 124	UST 324	UST 324A	UST 424
UST 125	UST 325	UST 325A	UST 425
UST 126	UST 326	UST 326A	UST 426
UST 127	UST 327	UST 327A	UST 427
UST 128	UST 328	UST 328A	UST 428
